Manhole Inspection Summary

Manhole # S17EE1022MH

Insp Date: 1/11/07 1:28 PM

Location Address: **3840 GREENSPRING AVE**

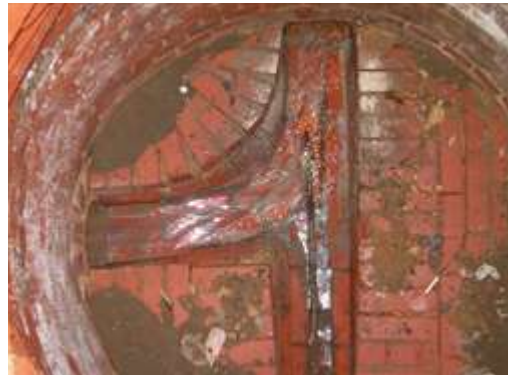
Top View

Evidence of surcharge - Bench debris.

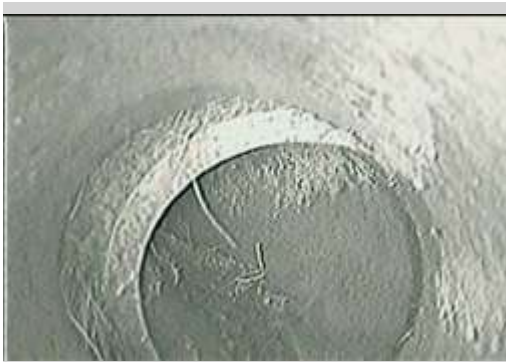
Inside the I6

Pipe offset and root intrusion.

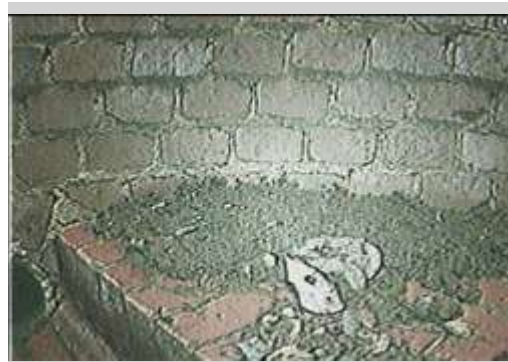
Defect

Barrel deterioration and infiltration.

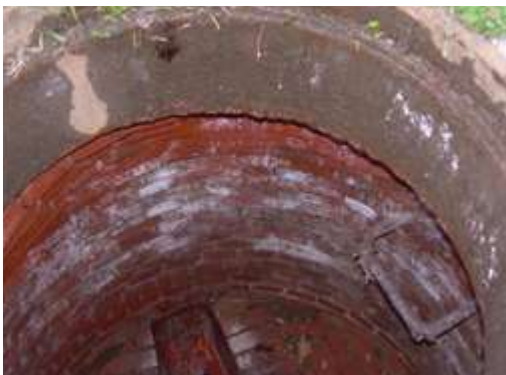
Defect

Frame leaks. Adjustment, Corbel and Barrel infiltration.

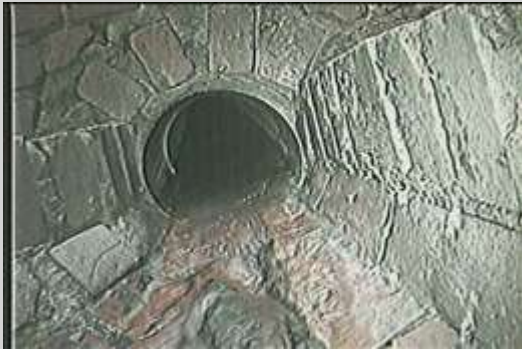
8 in. Circular Gravity Sewer Pipe Out @ 12 O'Clock

Barrel deterioration and infiltration. Channel deterioration.

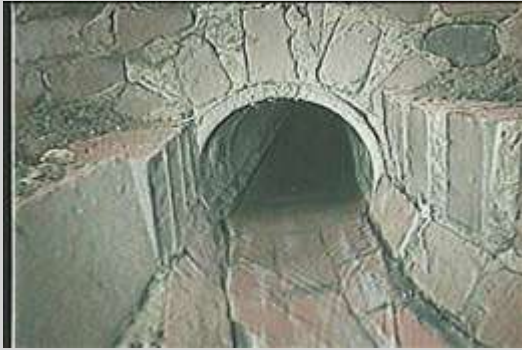
Pipe In @ 9 O'Clock

Barrel deterioration and infiltration. Channel deterioration.

Infiltration: **None** Pipe Seal Cond: **Cracked**
